**Subject:** Sky Valley Education Center

PCB air and wipe sampling in Annex Building

EHSI Project 10816-01

### Monroe School No. 103 District Sky Valley Education Center Collection and Analysis of PCBs in Air & Wipe Sample

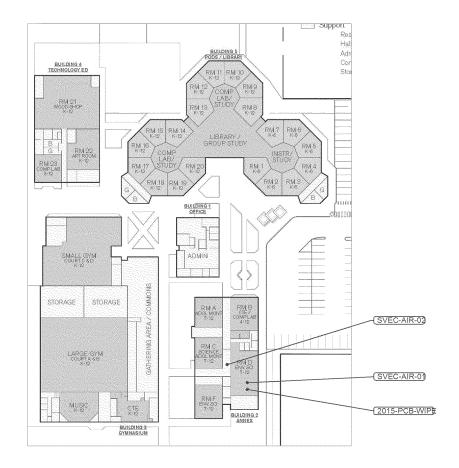
SL-1

Air samples were collected over a twenty-four (24) hour period using low flow Gilian sampling pumps calibrated to an airflow of 1.0 liter per minute (LPM). Samples were collected on 13 millimeter (mm) GFF Swinnex cassettes. A sample was collected from the room in which the ballast recently failed and an additional, comparator sample was collected from a "non-affected" area within the same annex building. Sample collection began on at 8:34am on December 23<sup>rd</sup> and concluded at 8:40am on December 24<sup>th</sup>, 2015. A wipe sample was also collected from the vinyl floor tile where the ballast oil had leaked onto the carpet. The carpet in the affected area was removed prior to this assessment. A wipe sample was taken from a 100 square centimeter (cm²) area. Sampling locations are denoted on the floor plans provided in Appendix A of this report.
